Tasmanian Irrigation

Dial Blythe Construction Update - October 2014

South Riana Dam

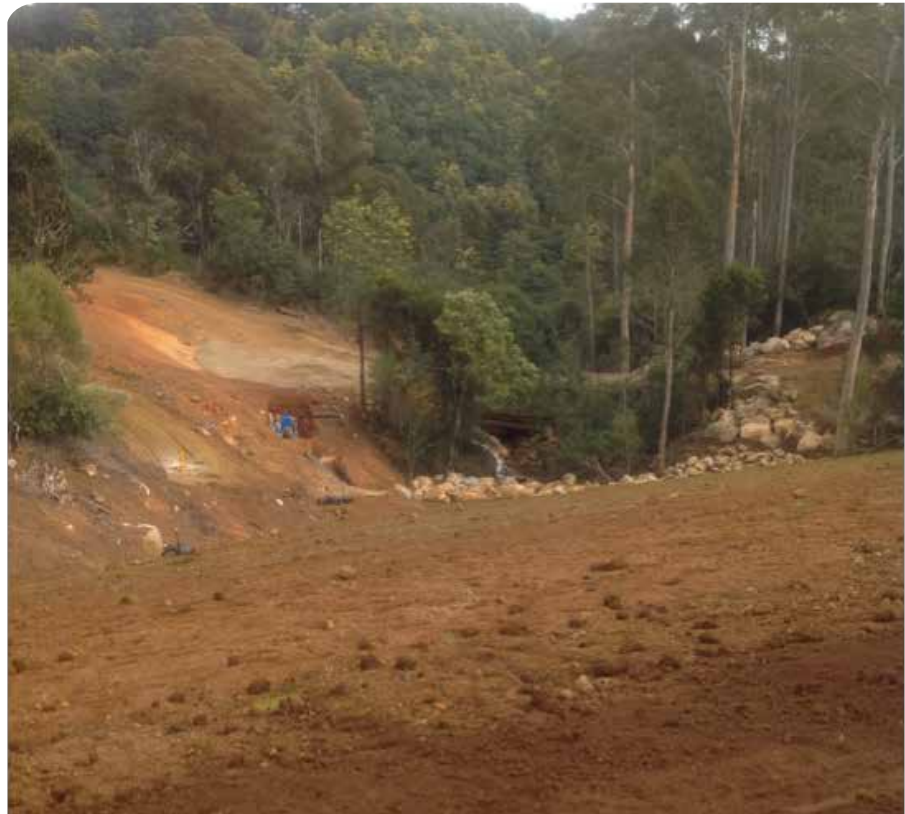
Figure 1: South Riana Dam pump station pad from the top of the dam wall

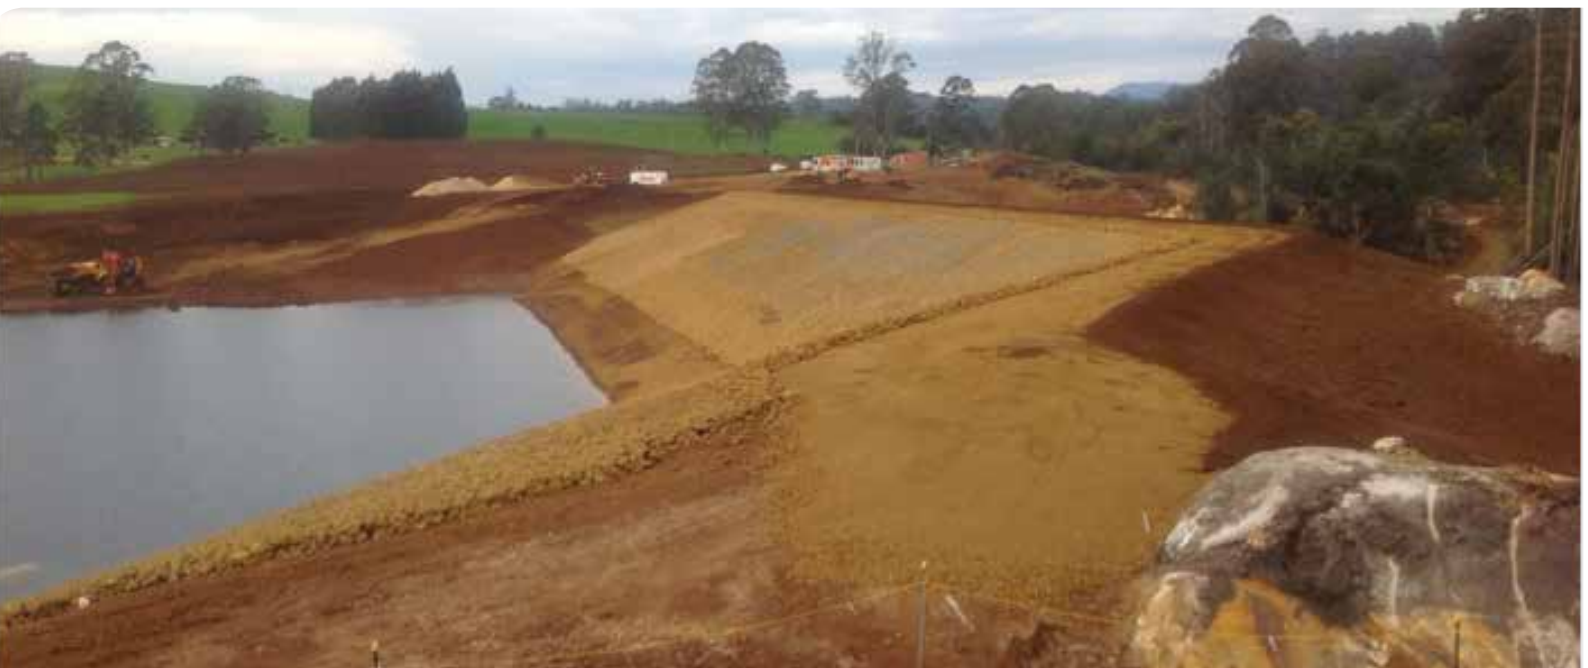
Figure 2: South Riana Dam completed earthworks

Earthworks at the South Riana Dam are now completed with a final wall height of 18m and a crest of RL301m. Some 83,000 m³ of earth has been placed in the wall. Finishing touches have been completed with the rock rip rap in place and the back side of the wall now seeded, the borrow areas rehabilitated and the vegetation within the inundation being removed. To have been able to complete these works through the winter period has been nothing short of fantastic. Work at the dam site is now concentrating on the spillway concreting and construction of the pump stations.

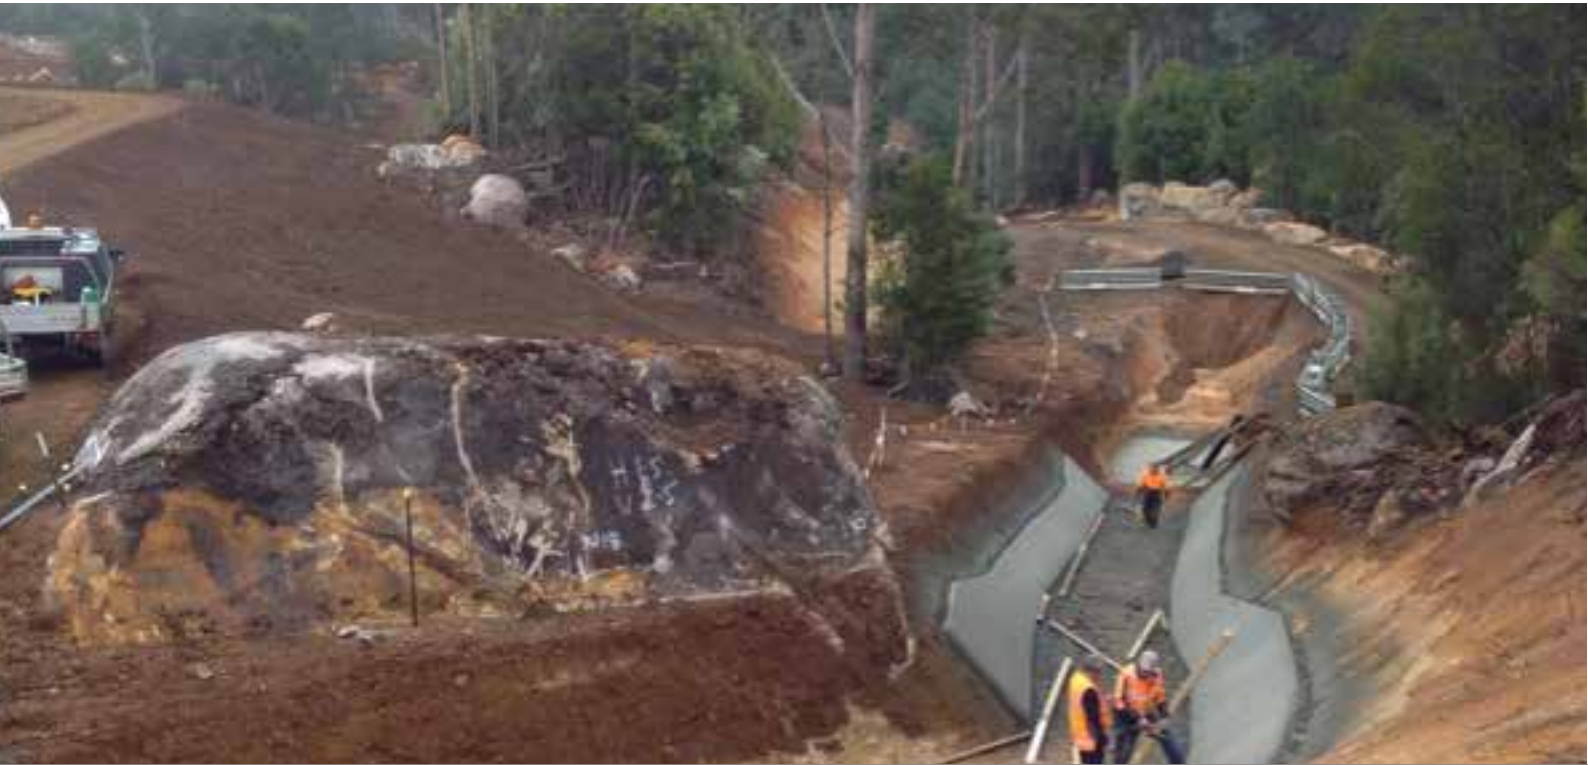
Figure 3: Spillway concreting works

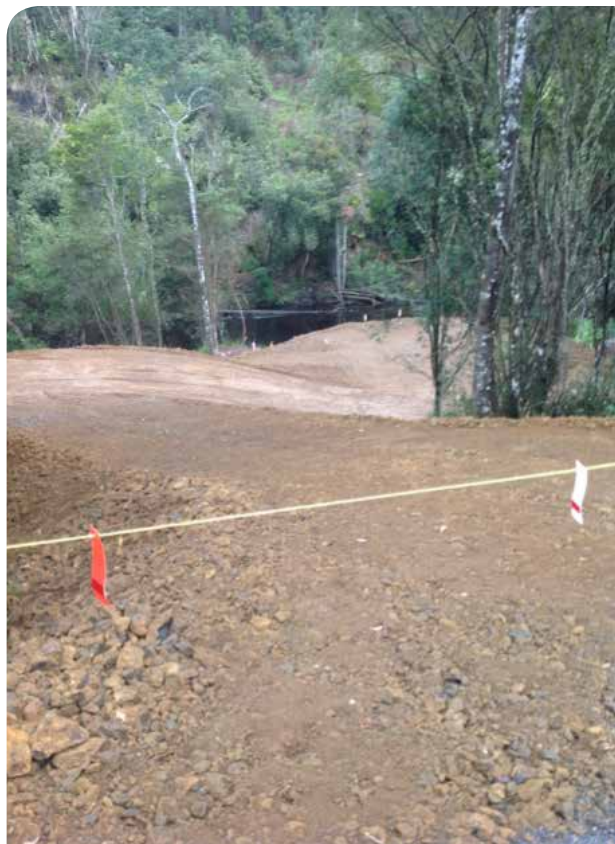
Figure 4: Blythe River pump station pad from South Riana Road

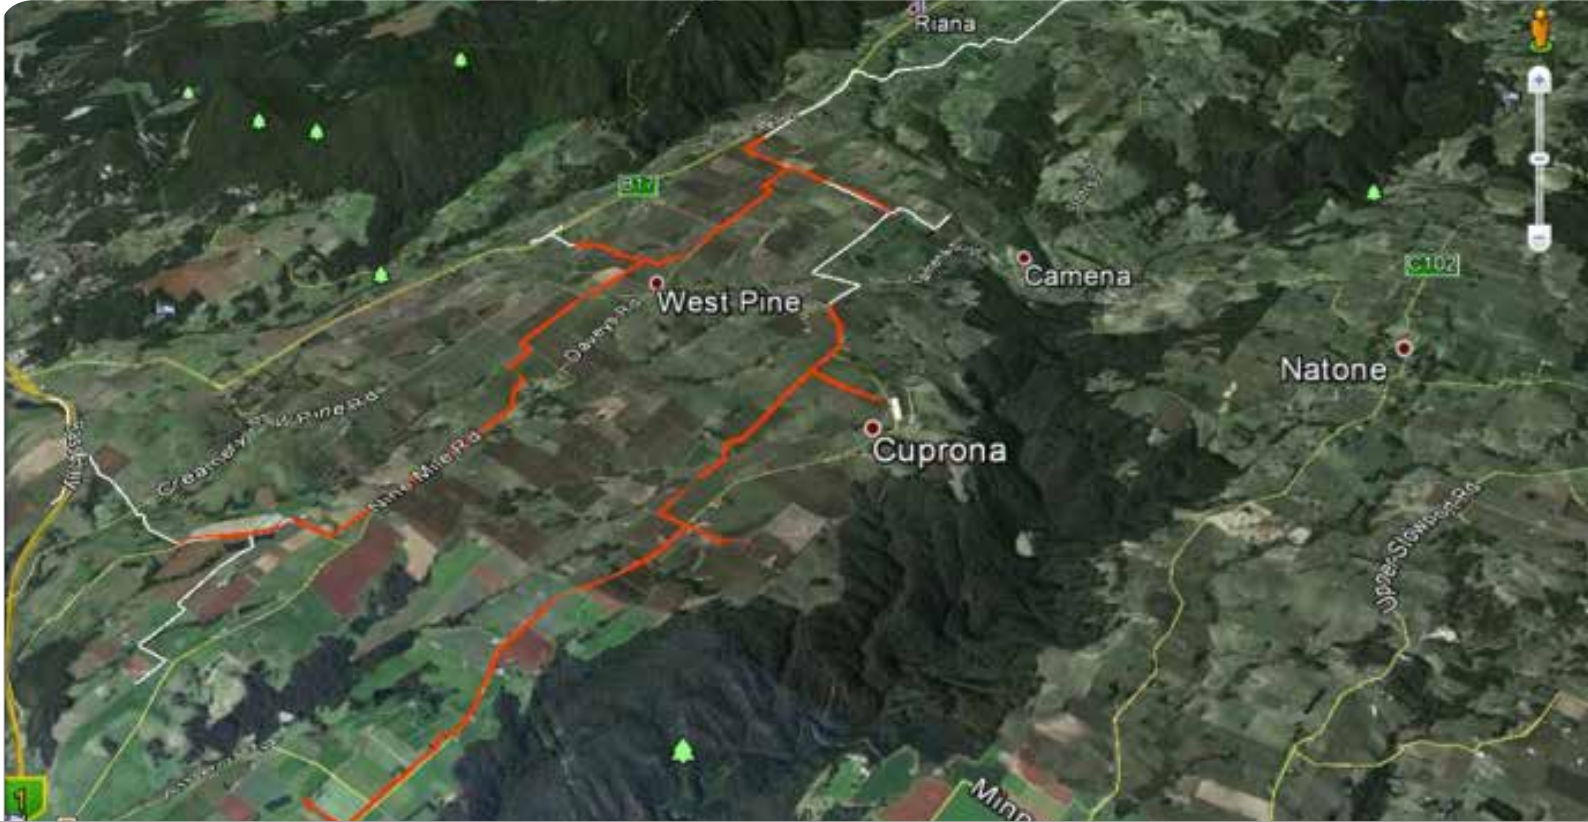
Figure 5: Pipeline installation progress

Pipeline installation also has seen no stopping through the winter period, and some 20km of the 42.5km of pipe has now been installed. Works have included the installation of all of the underground infrastructure with the fit out of valves and outlets being completed with the pipeline installation. This has meant that there will be limited reason to return to properties, other than for commissioning works. Nearly all of the cropping lands have had the necessary pipe installed through the winter period, and as such the works have concentrated north of Copes Road. Work is now starting to head south from Copes Road and will shortly start at the South Riana Dam and work north. Currently there are two pipe installation crews and four welding crews in action.

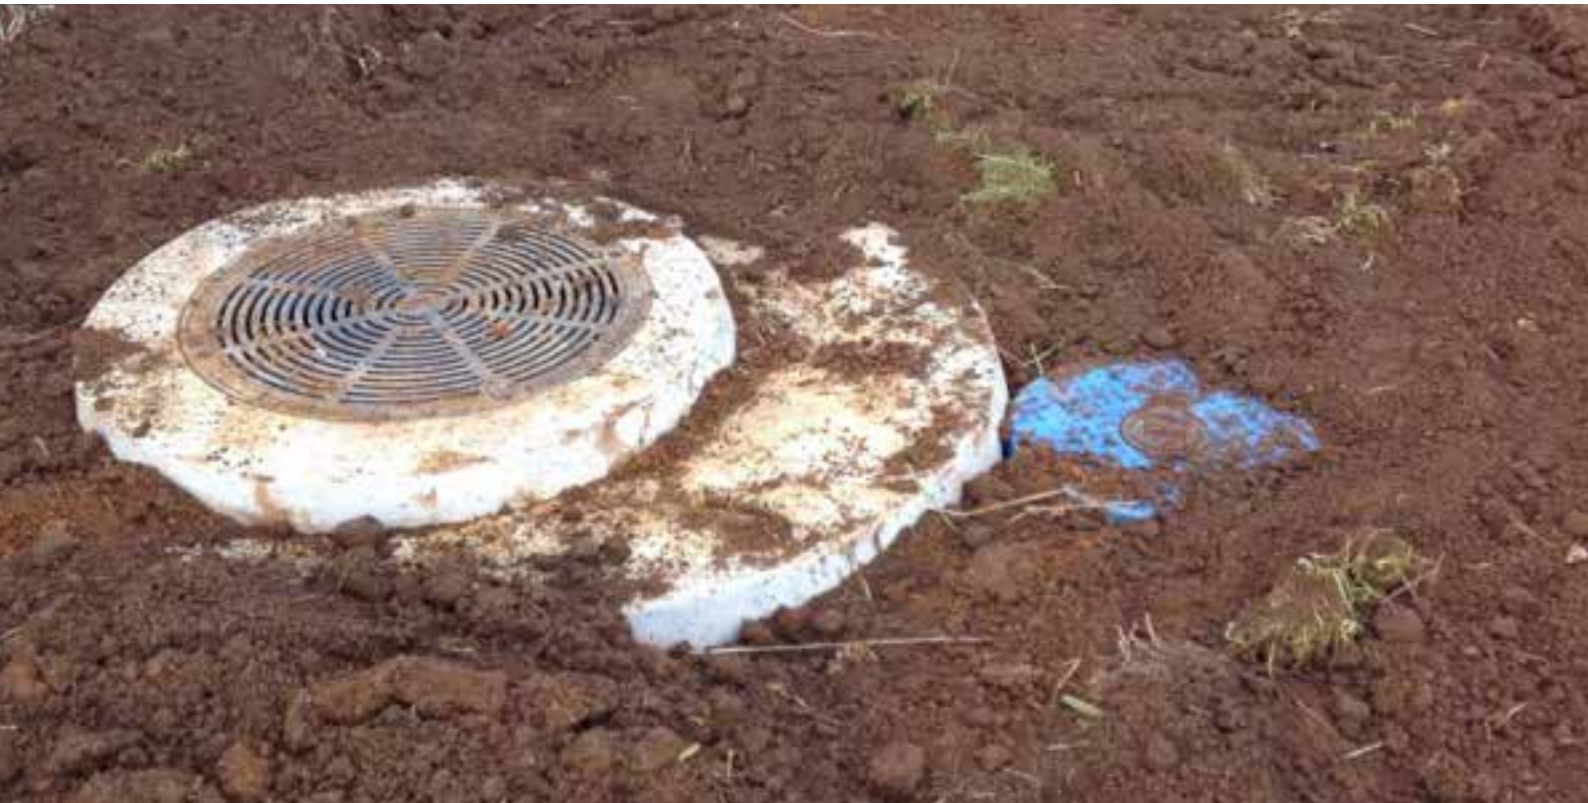
Figure 6: Scour or drain valve pit

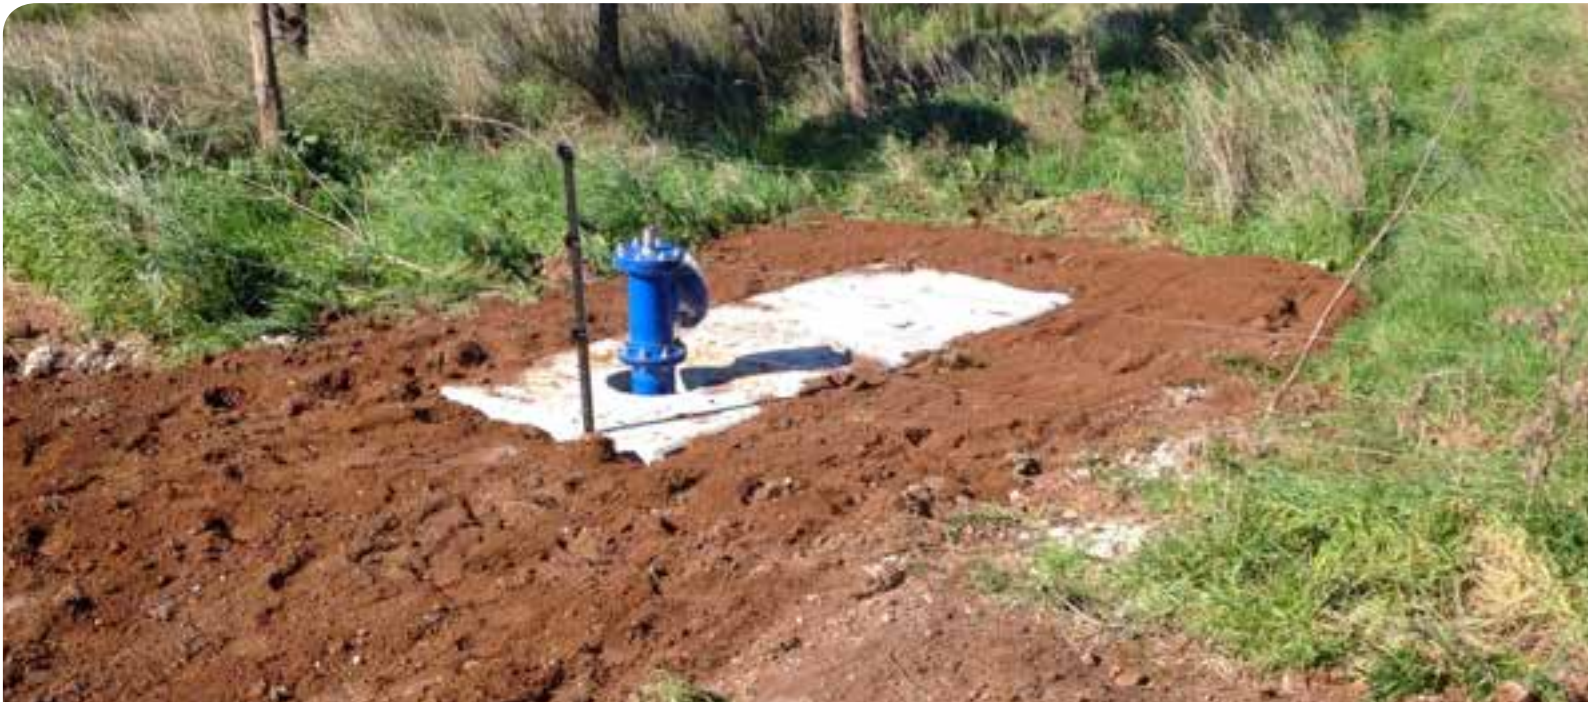
Figure 7: Outlet riser and slab waiting for valve train and cage

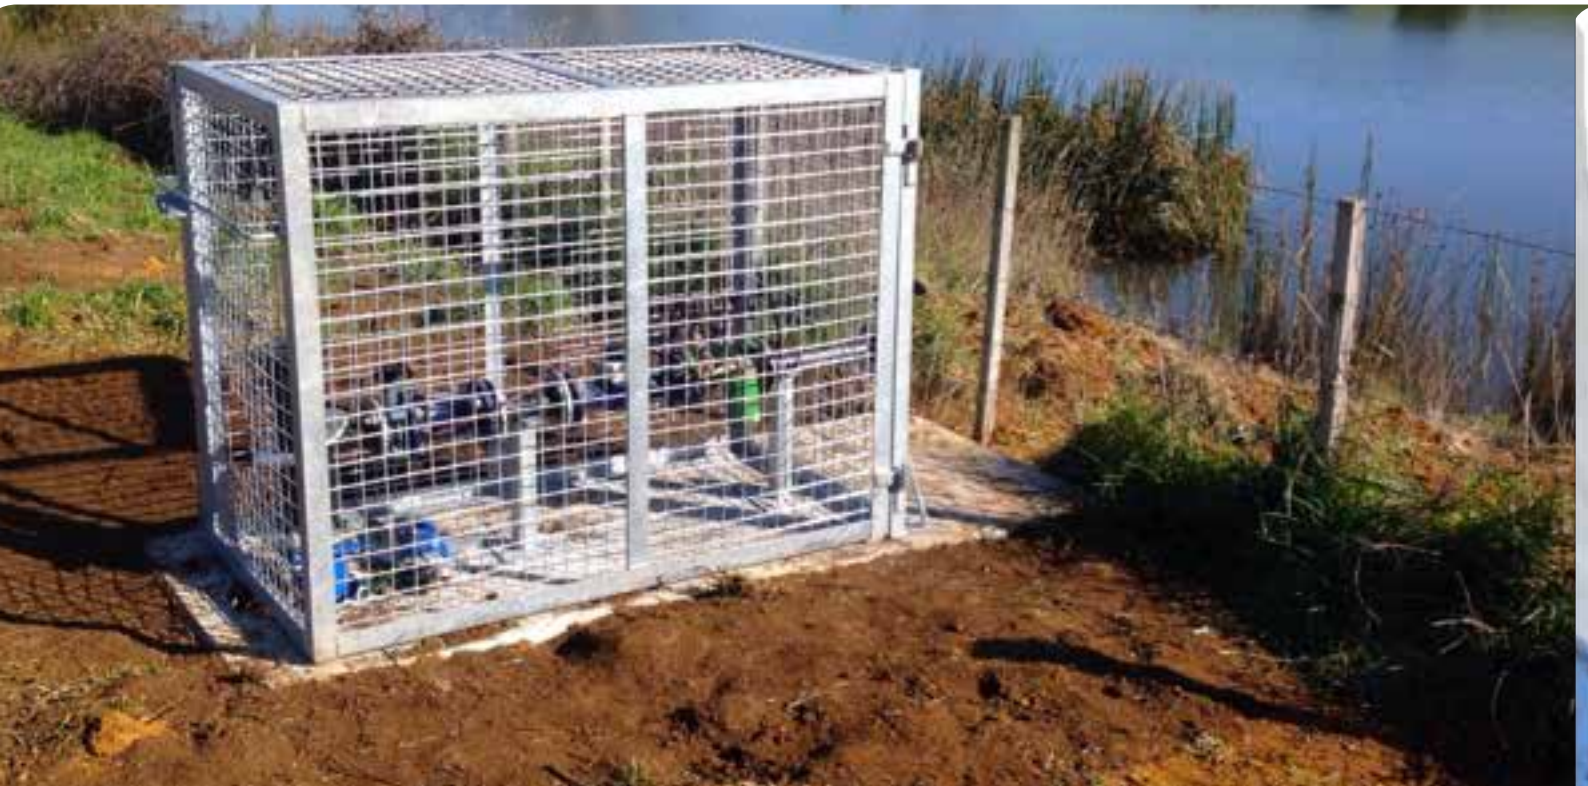
Figure 8: Completed outlet cage Cuprona

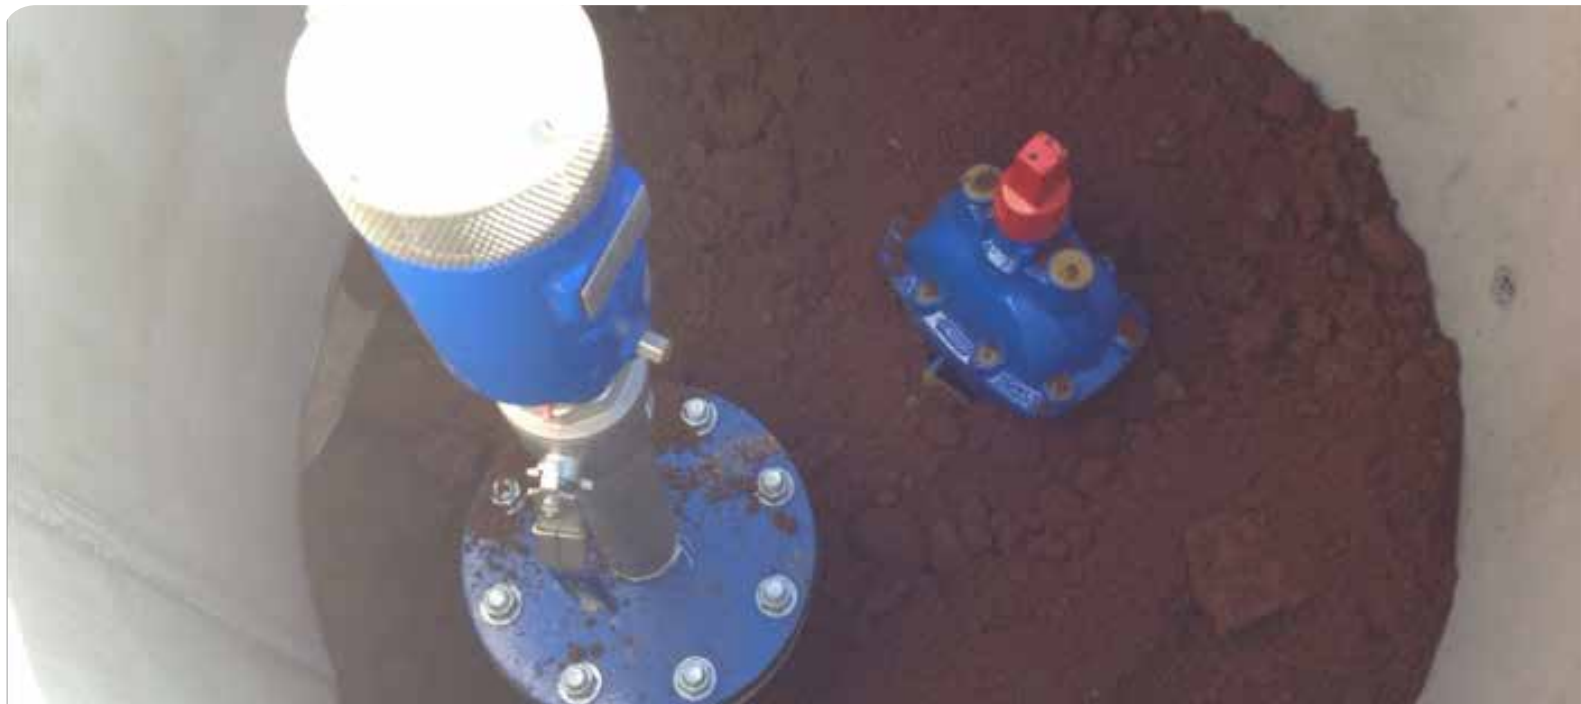
Figure 9: Isolation valve and air valve

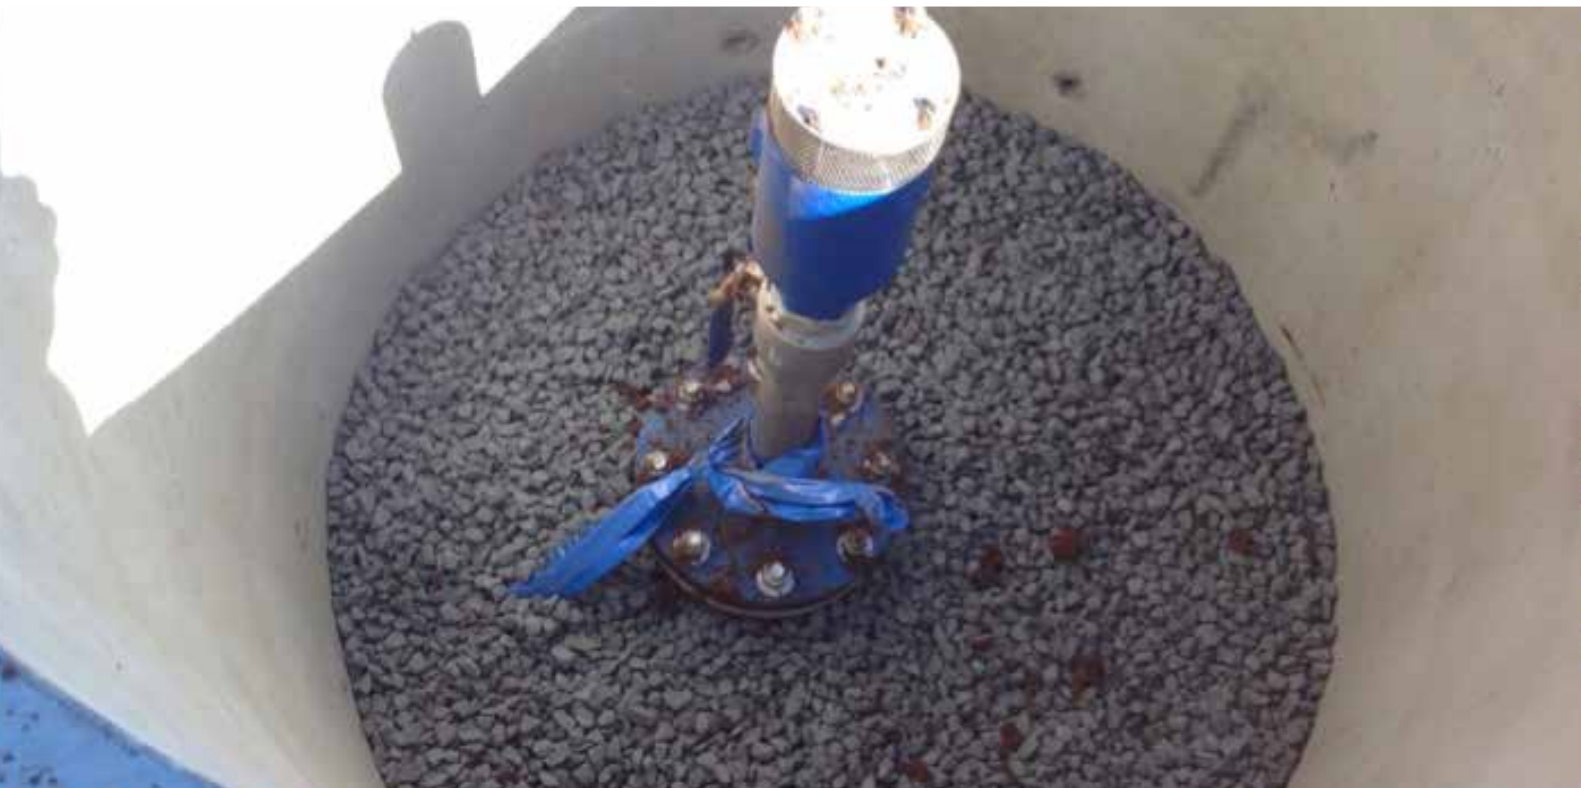
Figure 10: Completed air valve installation

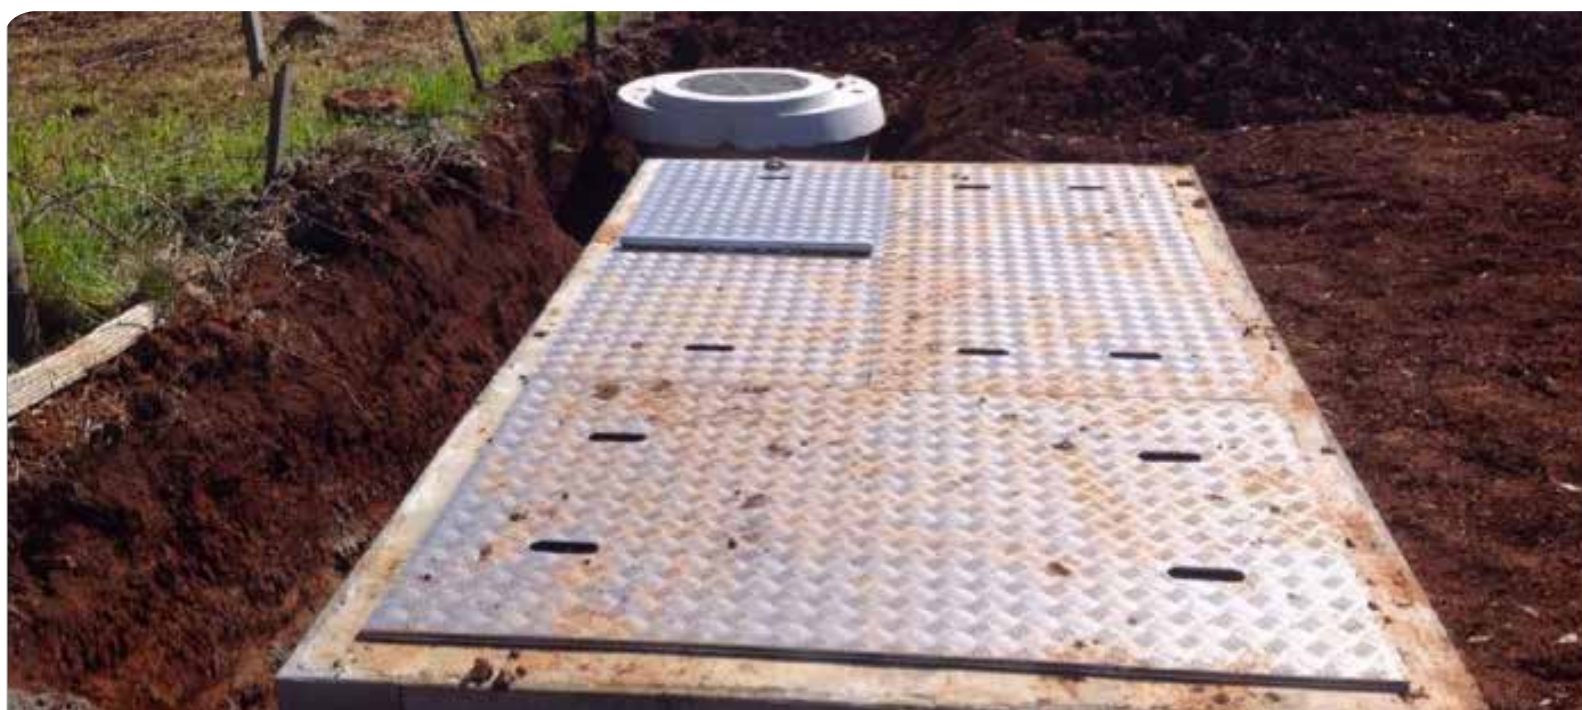
Figure 11: Pressure reduction valve pit West Pine
